Llanganten

SO 009517
2583

Introduction

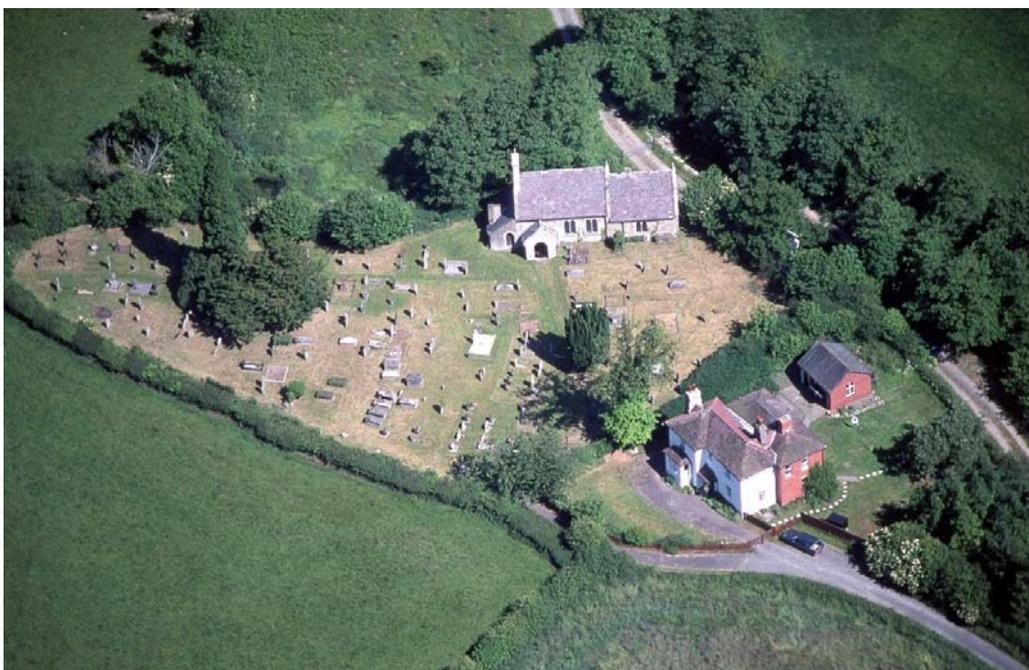
Llanganten village, photo 95-C-0326 © CPAT 2011
