Llangynog

SO 024459
2584

Introduction

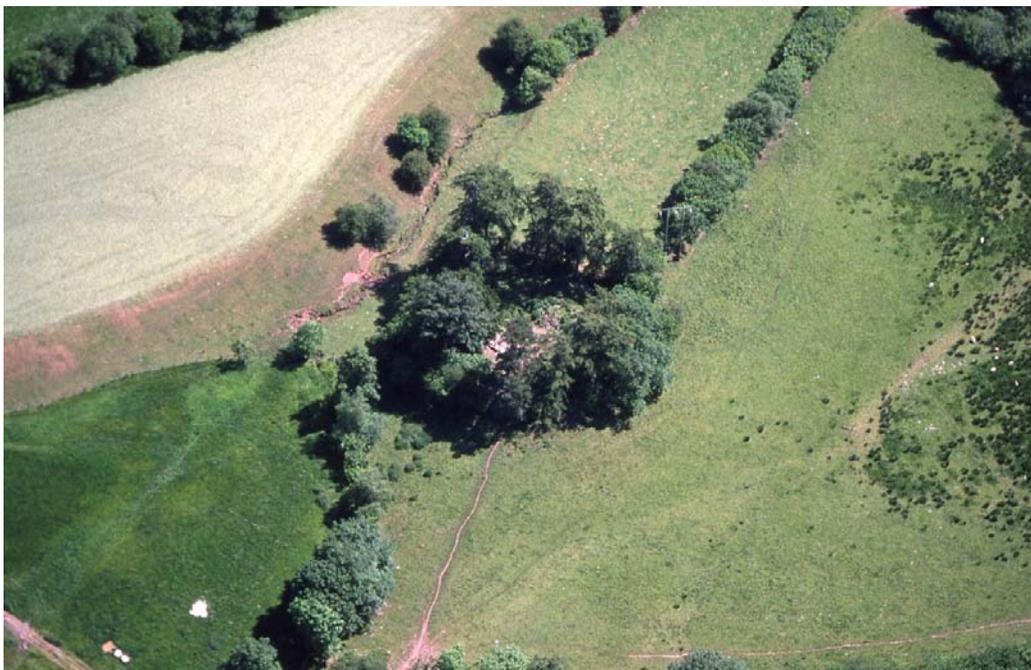
Remains of Llangynog church, photo 95-C-0399 © CPAT 2011

St Cynog's Church (20153) was apparently a small, singled-celled structure of medieval type, although mainly of 17th-century and 18th-century build according to existing records. It was largely rebuilt in 1882. The building does not figure in medieval records and its earliest documented date is 1717, although it is possible that it was of early medieval origin (see below).

The church sits within the remains of a raised sub-circular churchyard (5483), no more than 35m across and contained by a dry-stone revetment wall. This is a characteristically early medieval shape, although there is no corroborative evidence to support such an early origin.

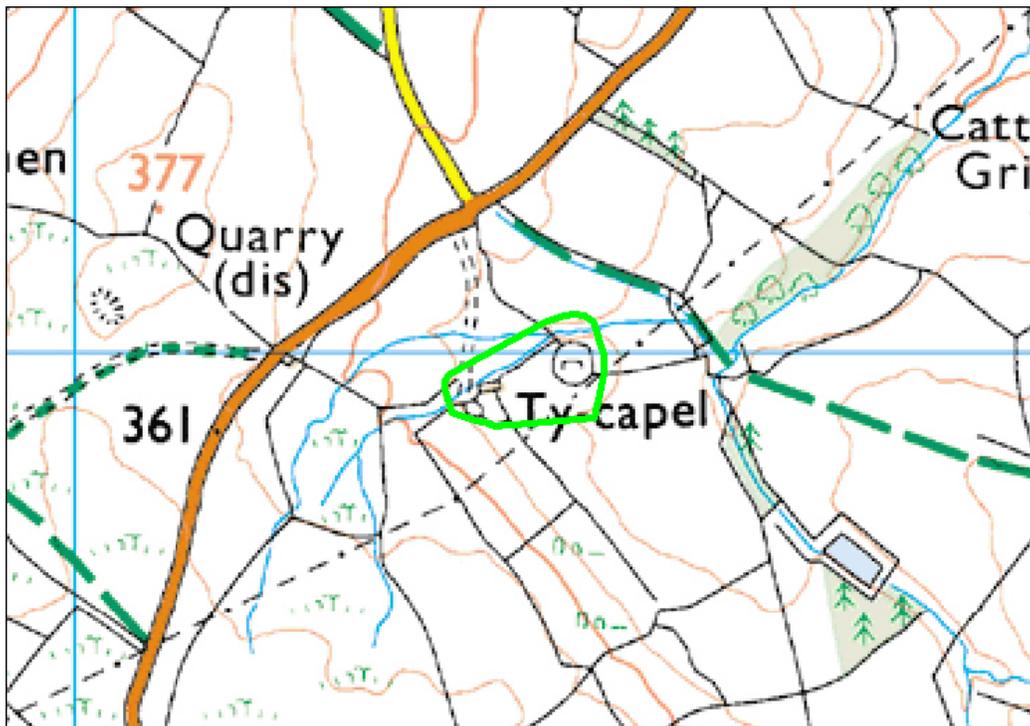
The accompanying map is offered as an indicative guide to the historic settlement. The continuous line defining the historic core offers a visual interpretation of the area within which the settlement developed, based on our interpretation of the evidence currently to hand. It is not an immutable boundary line, and may need to be modified as new discoveries are made. The map does not show those areas or buildings that are statutorily designated, nor does it pick out those sites or features that are specifically mentioned in the text.
