St Harmon

SN 98857281
16195

Introduction

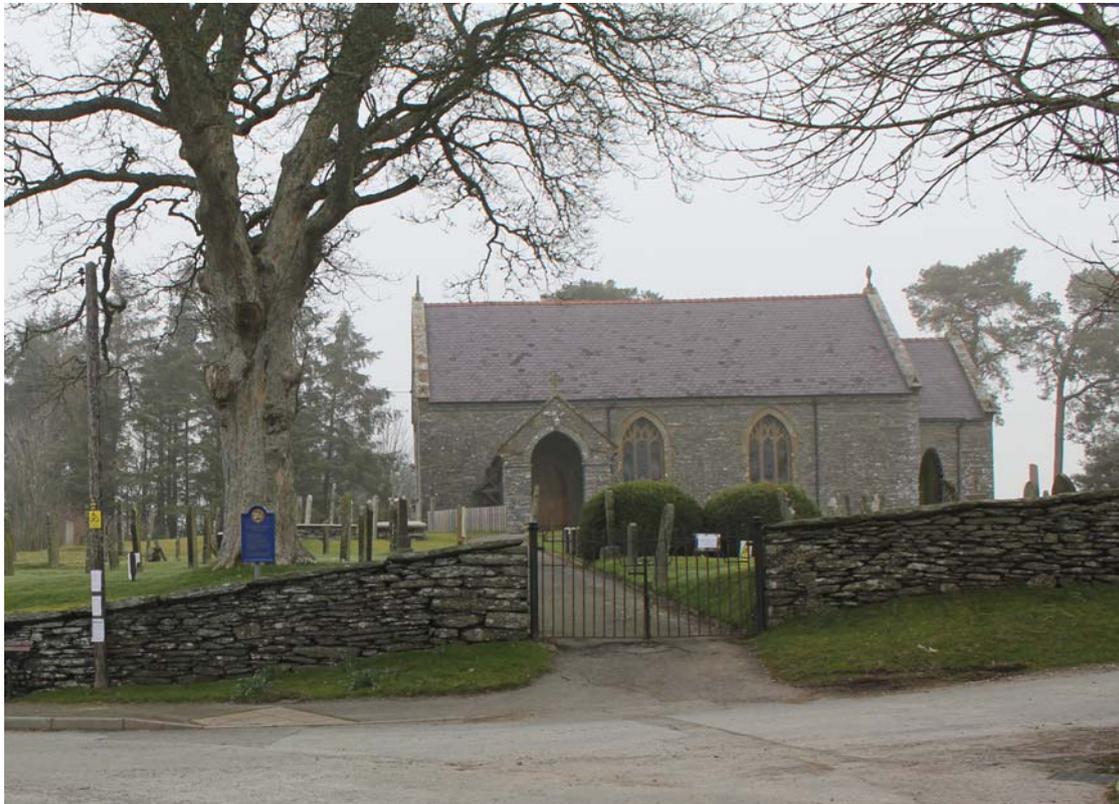
St Harmon church, photo 3247-0002, © CPAT, 2011

St Garmon's church (16053), now consists of a nave, chancel and south porch. The 'low, long and dark' church of medieval date was replaced in 1821 and a new chancel and vestry were added in 1908. It contains a font of 11th/12th-century date, but nothing else of pre-Reformation origin. Some of the stone from the earlier building was probably used in the construction of the adjacent Llawr-llan farmhouse which bears a datestone of 1821.

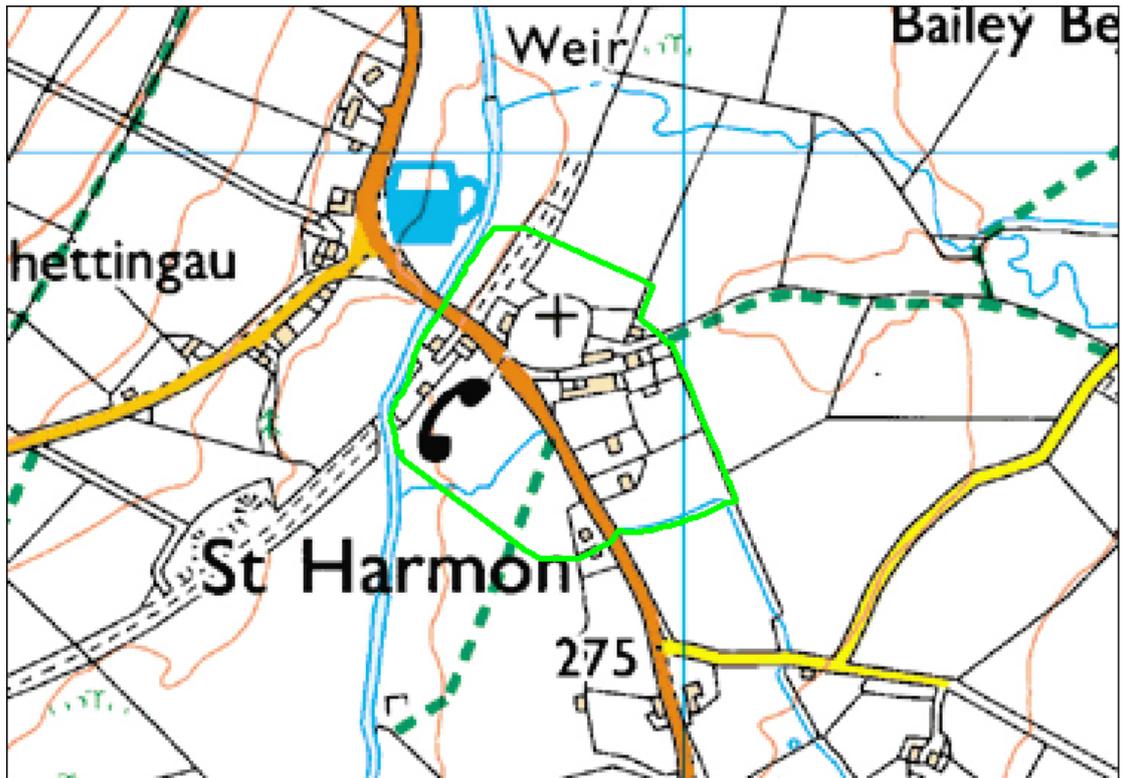
The accompanying map is offered as an indicative guide to the historic settlement. The continuous line defining the historic core offers a visual interpretation of the area within which the settlement developed, based on our interpretation of the evidence currently to hand. It is not an immutable boundary line, and may need to be modified as new discoveries are made. The map does not show those areas or buildings that are statutorily designated, nor does it pick out those sites or features that are specifically mentioned in the text.
