CPAT Report No. 1679

Vessel wreck at Pensarn Beach, Abergele

Preliminary Survey

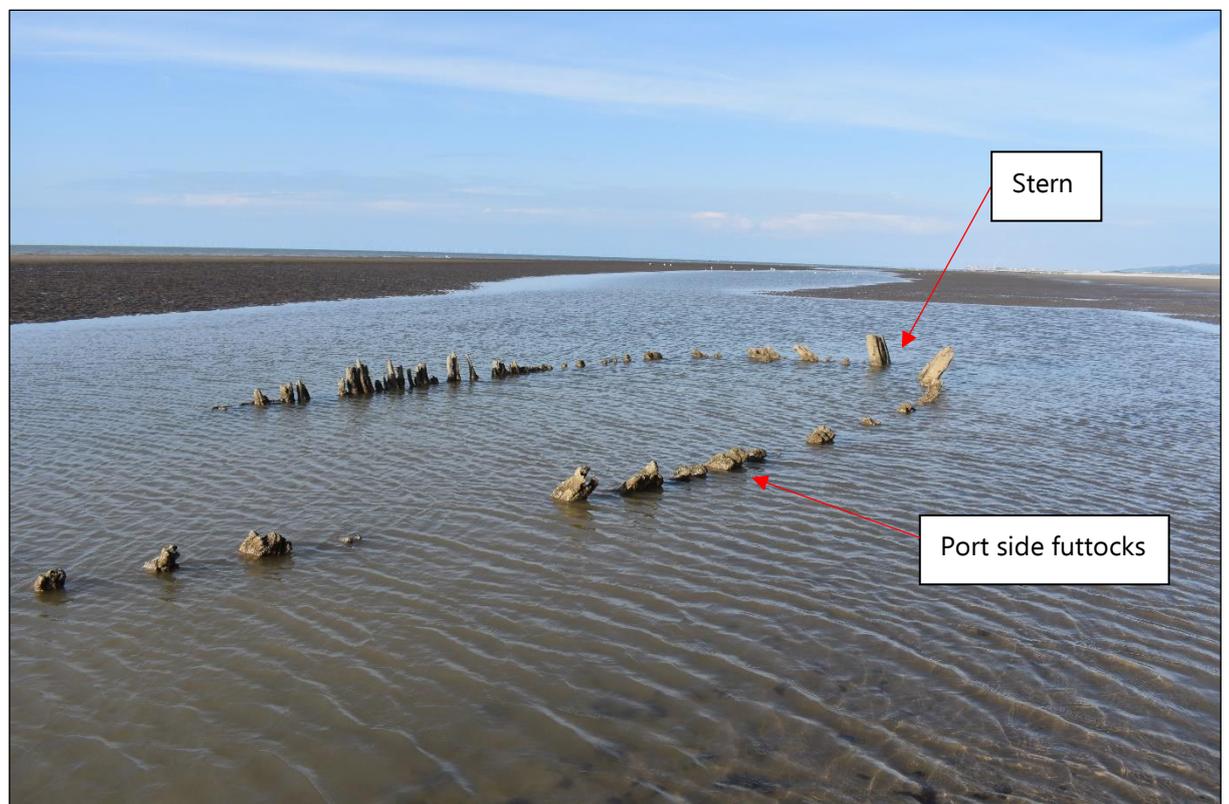
- 3.4. Elements of both the futtocks of the port and starboard side were visible. The starboard forward futtocks were not visible (Fig. 2).

Fig. 2 Port and starboard futtocks viewed from the south-west Photo CPAT 4674-0007

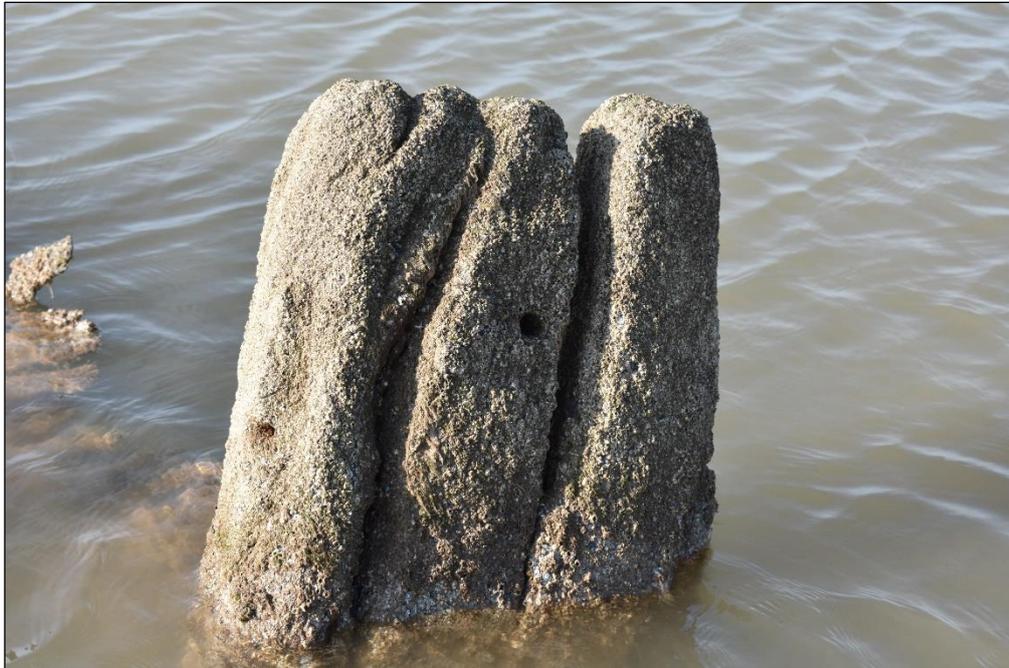
- 3.5. Approximately 1.0 m of the sternpost were extant (below/above the waterline) with 0.20 m visible above the waterline (Fig. 3).

Fig. 3 Sternpost viewed from the south Photo CPAT 4674-0004

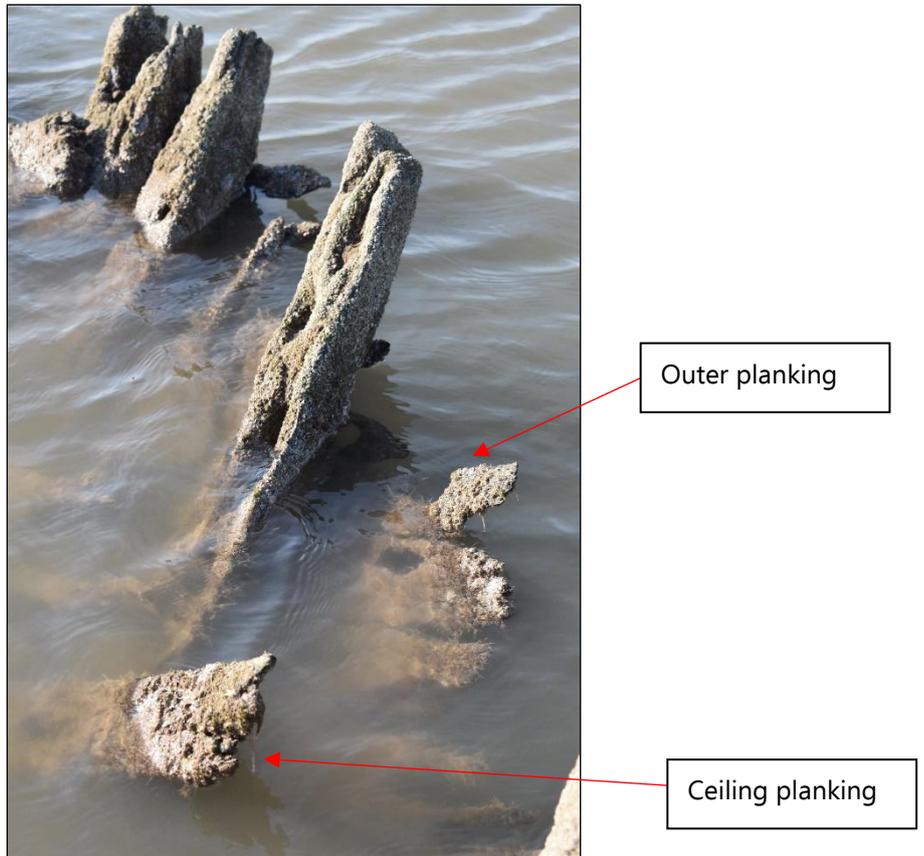
- 3.6. Portions of the outer planking were visible just above and beneath the waterline. Due to the depth of the water and poor conditions underfoot, it was not possible to approach close enough to measure these elements. Based on visual observation from a distance of several metres, the outer planks appeared to be placed flush suggesting a carvel method of construction (outer planks flush) rather than clinker (outer planks overlapping).

- 3.7. Clinker-built vessels tended to be predominant in Northern Europe prior to the introduction of carvel methods from the 17th century onwards (Eriksson, 2010, 78), which may suggest a later period of construction for this vessel. However, it is difficult to assign a high degree of confidence to build methods without being able to approach these elements closely. Near the sternpost the outer and ceiling planking curved upwards towards the sternpost (Fig. 4). On the starboard side, the outer planking was visible just below the waterline and appeared horizontal (Fig. 5).

Fig. 4 Planking near sternpost viewed from the south. Photo CPAT 4674-0020

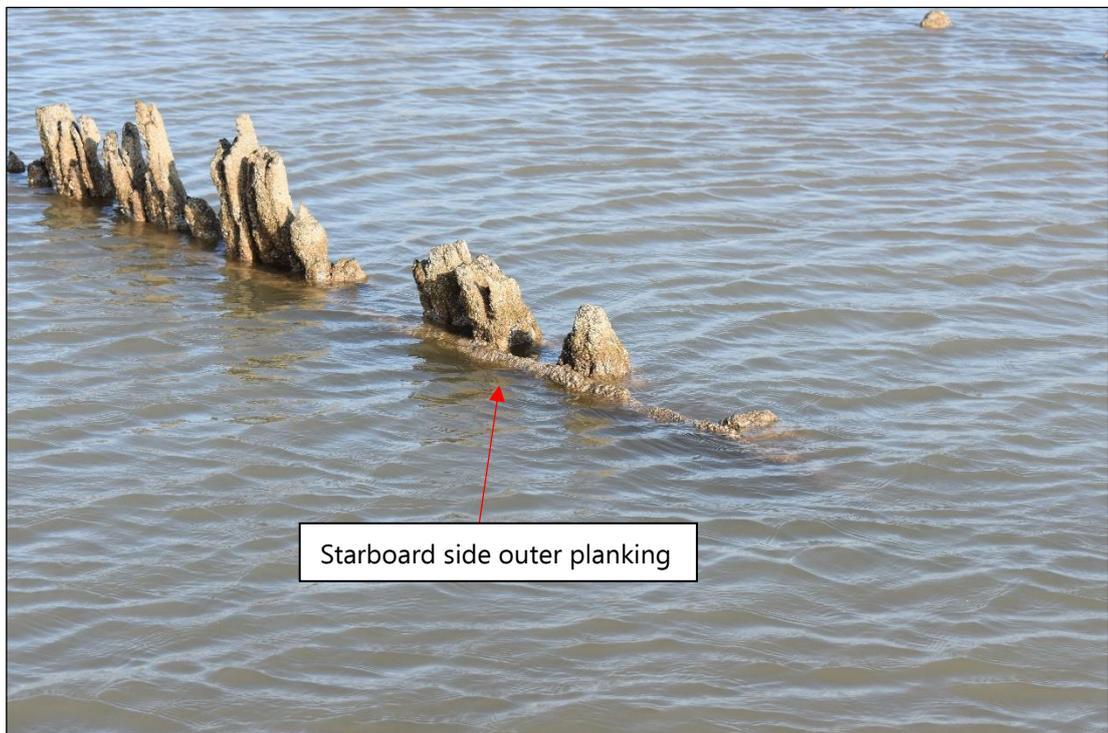
Fig. 5 Starboard side viewed from the north-west. Photo CPAT 4674-0012

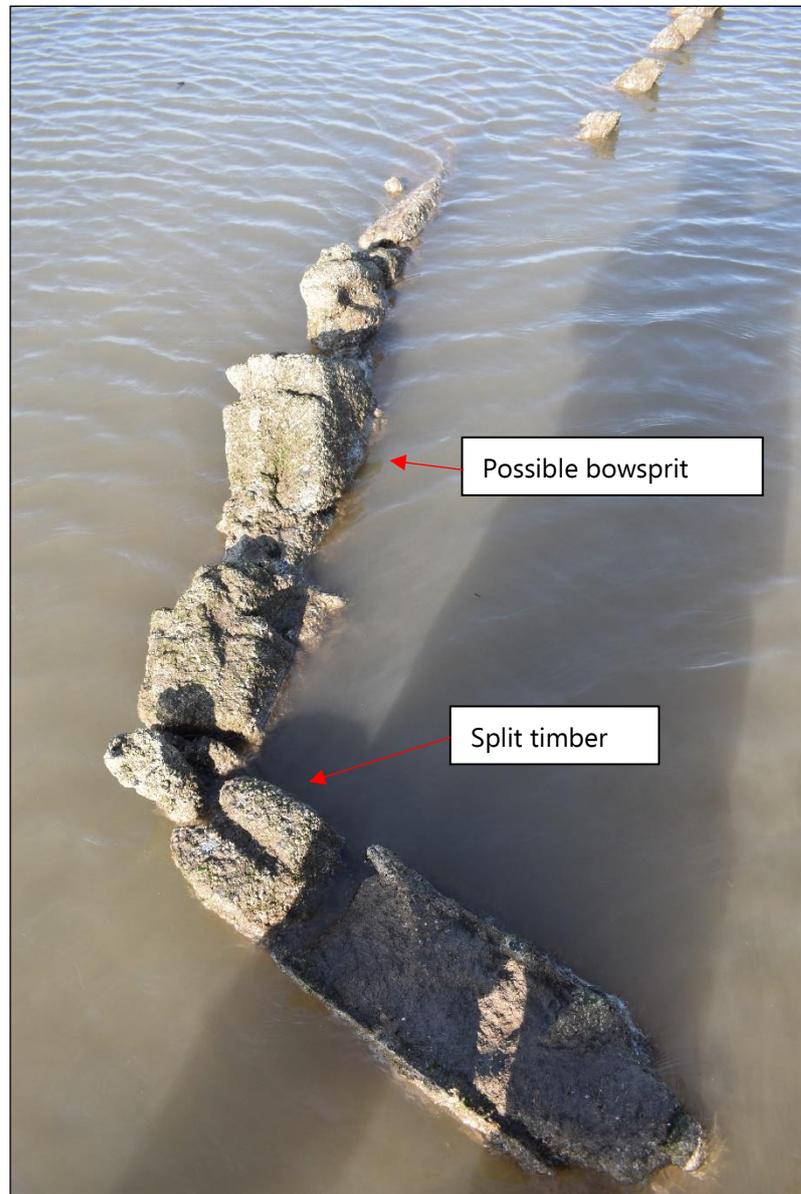
- 3.8. A length of timber, aligned off-centre to the port side was visible. This extended beyond the bow and given its size and position may represent the bowsprit, a spar running out from a ship's bow, to which the forestays are fastened. The timber appeared to have split and a portion of it was aligned inshore. It is also possible this element is a disconnected jib-boom, is a spar used to extend the length of a bowsprit (Fig. 6).

Fig. 6 Timber, extending beyond the bow, viewed from the west. Photo CPAT 4674-0009

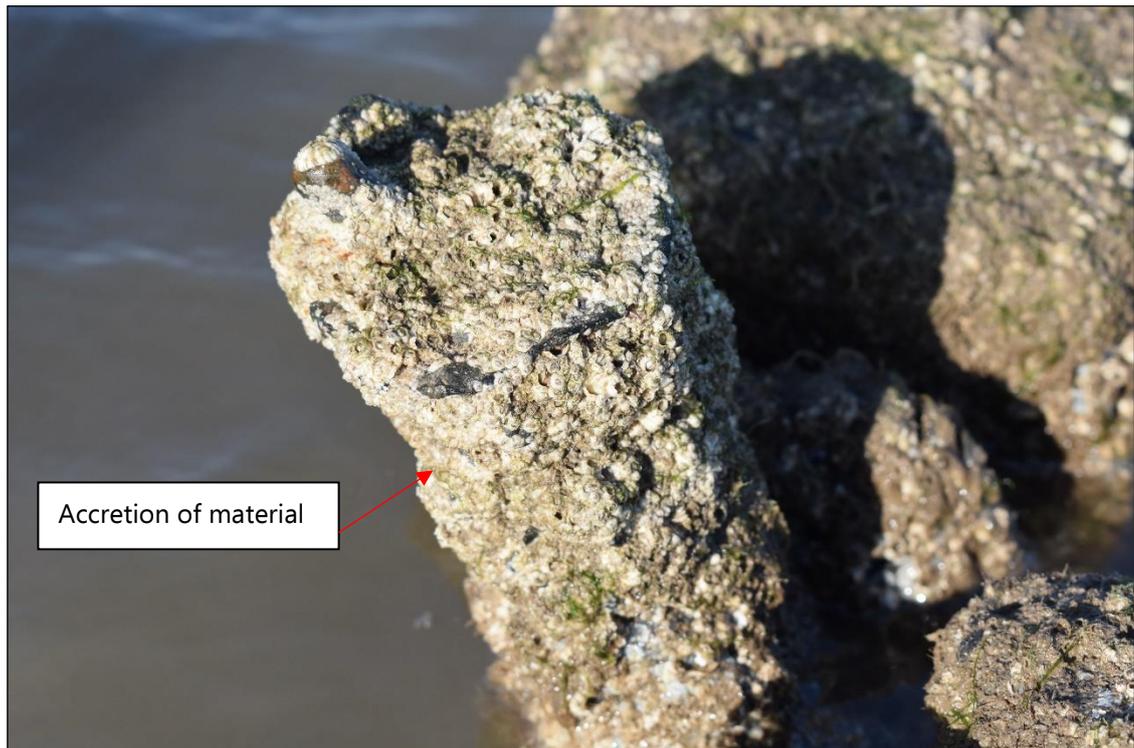
- 3.9. All the visible timbers had undergone significant accretion of material (Fig. 7). The tips of some of the futtocks showed evidence degradation with exposed fresh timber visible (Fig. 8).

Fig. 7 Accretion materials of timber. Photo CPAT 4674-0023

- 4.2. It is recommended that the site is fully surveyed using survey grade differential GPS to gain accurate measurements and dendrochronological and timber identification sampling is conducted to gain accurate dating information. This should be carried out as soon as is feasible given the active degradation of the site. These methodologies have been used successfully at other beach wreck sites in the UK, for instance the Bamburgh Castle beach wreck, dated to AD 1768 (Bale, 2014, 3). Following the application of these methods, the site is now a scheduled ancient monument. It is also possible that further degradation of the wreck can be mitigated by the various conservation methods such as the additional deposition of sand and stone layers which are known to have positive impact on site preservation in partially submerged contexts (WreckProtect, 2011, 37).

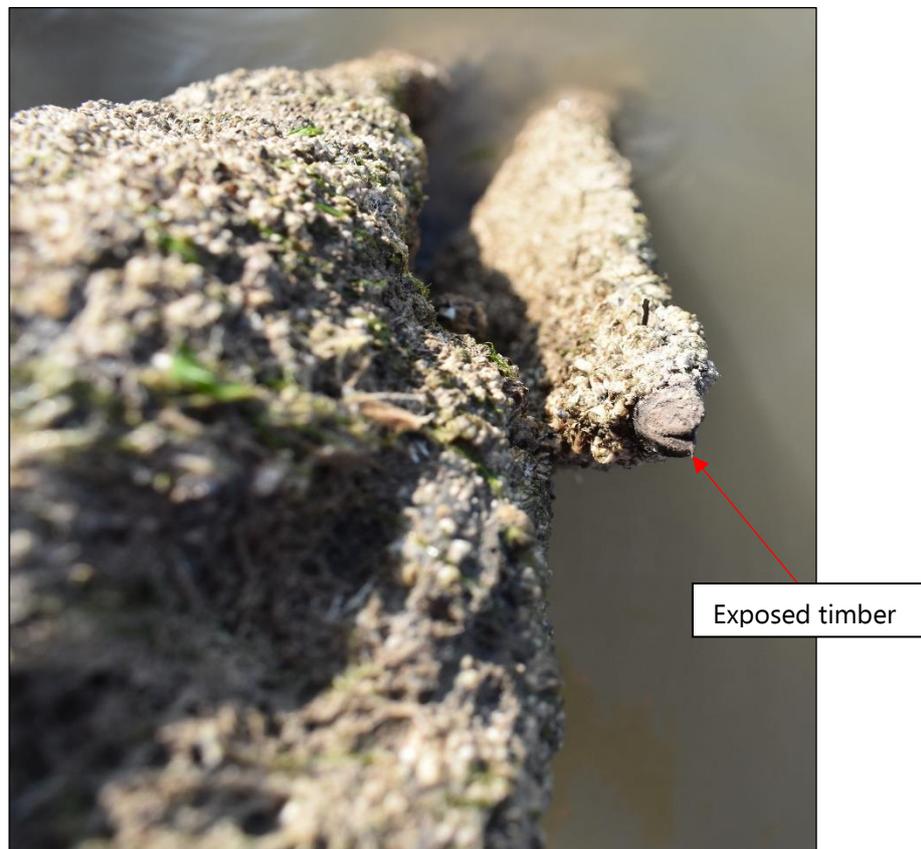
Fig. 8 Exposed timber at tip of futtock. Photo CPAT 4674-0022

- 3.10. It is likely that elements of the keel and floor timbers survive beneath the sediment, given the preservation of the lower futtocks and planking. Where it was possible to physically evaluate the extent of the vessel below the waterline, near the bow, the surviving structure appeared to extend below the loose sediment.
- 3.11. No artefacts or small finds could be seen exposed at the site.
- 3.12. Considering the short duration of exposure of the vessel, the freshly exposed timber shows active and rapid degradation of the wreck. This most likely due to the mechanical effect of water currents and waves (WreckProtect, 2011, 14).
