CPAT Report No 1249

Military Aircraft Crash Sites

SCHEDULING ENHANCEMENT PROGRAMME

February 2014

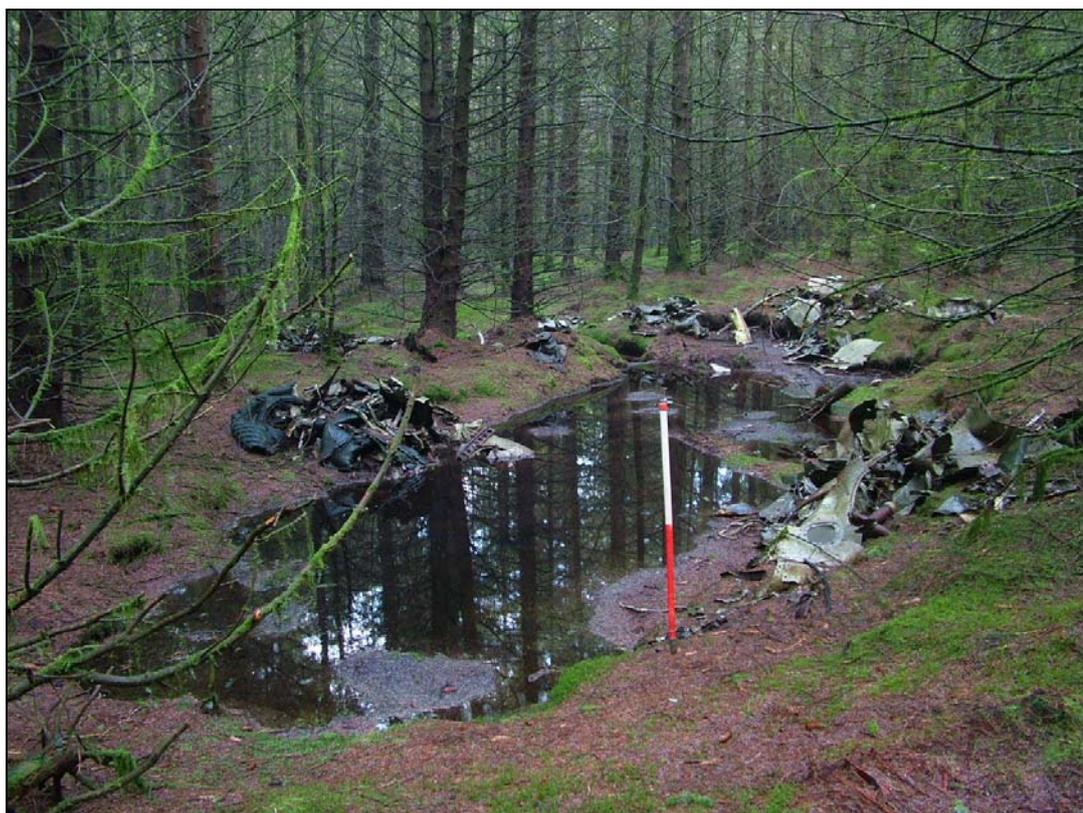
Fig. 2: The impact site and disturbed wreckage of Grumman Avenger FN821, in forestry near Llangynog, Powys (Photo CPAT 3732-0123)

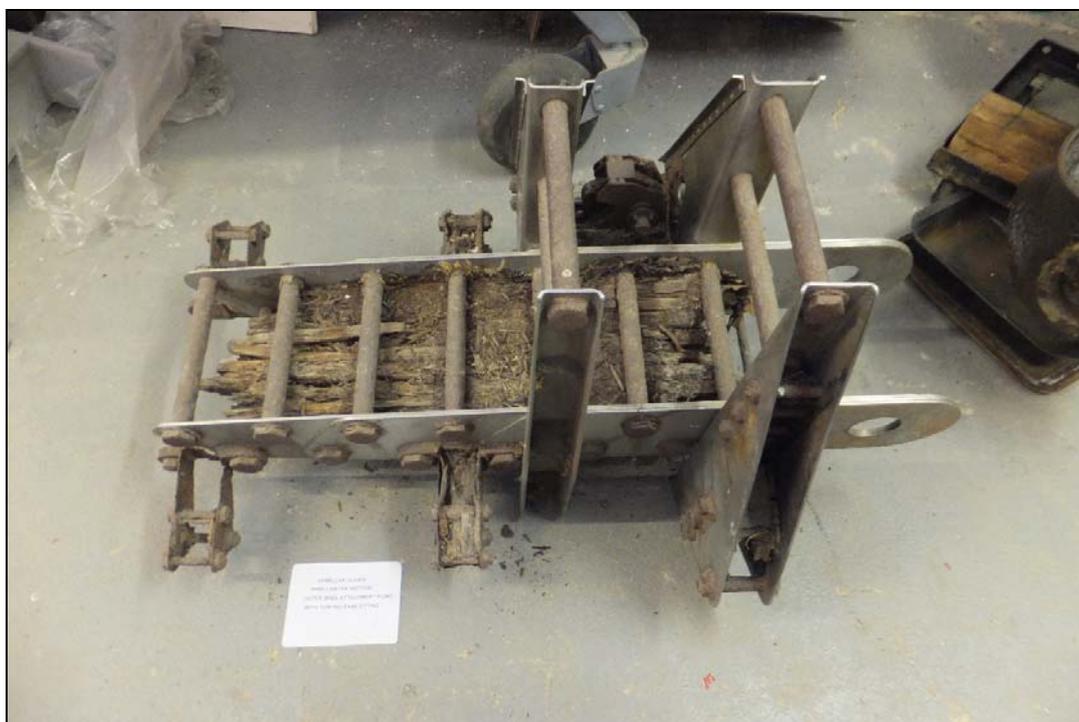
Fig. 3: Part of the wing centre section of Hamilcar HH922, including a tow release fitting, in the Wartime Aircraft Recovery Group Museum at Sleaf, Shropshire (Photo CPAT 3732-0110)

Only one engine was found, in the bottom of the gully which descends steeply from the memorial. Some of the gearing on the front of the engine remains, but the cylinder heads are missing as are some of the barrels. Markings stamped on it read 'P30329, A763043F (possibly), PEG XVII'. This is possibly the one located "in the Caerfannell" (it is actually in a tributary gully) in the BBNP source, as nothing was found in the main stream gully. The position of the other engine was not apparent. It was subsequently discovered that the tail unit and the other engine had been recovered; they are now in the WARG Museum at Sleaf.

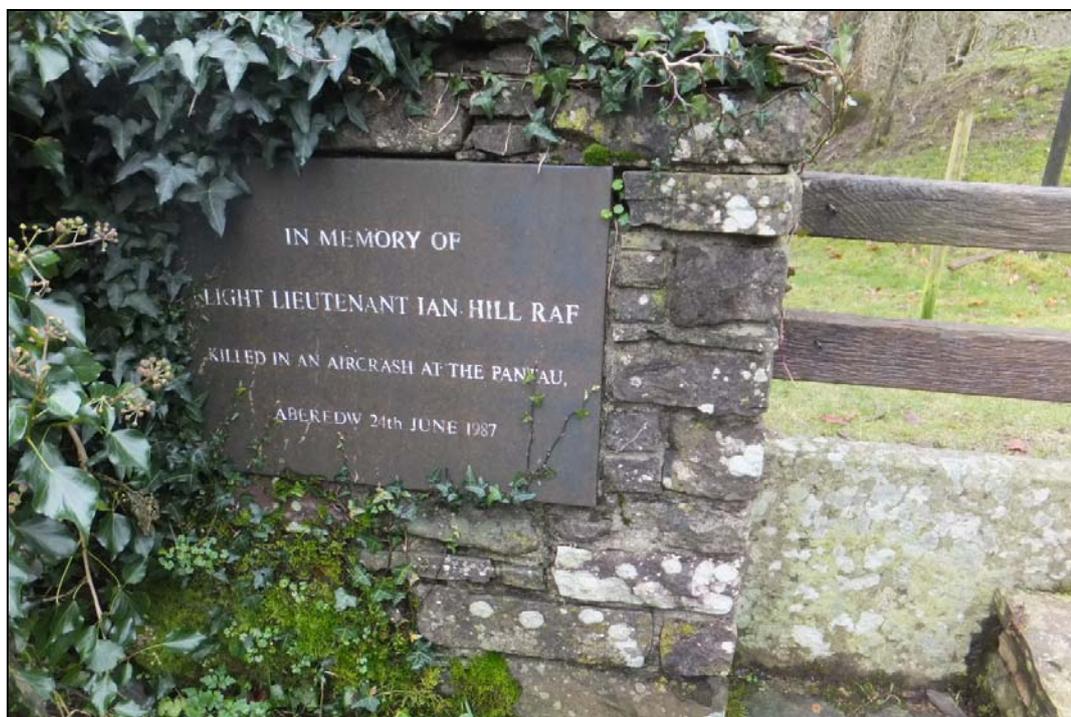
Fig. 4: The memorial to the pilot of Jaguar XZ386 on the wall surrounding Aberedw churchyard (Photo CPAT 3732-0092)

The memorial in the churchyard wall reads: 'In memory of Flight Lieutenant Ian Hill RAF killed in an aircraft at the Pantau, Aberedw 24th June 1987'. The memorial cairn and impact site were not found.

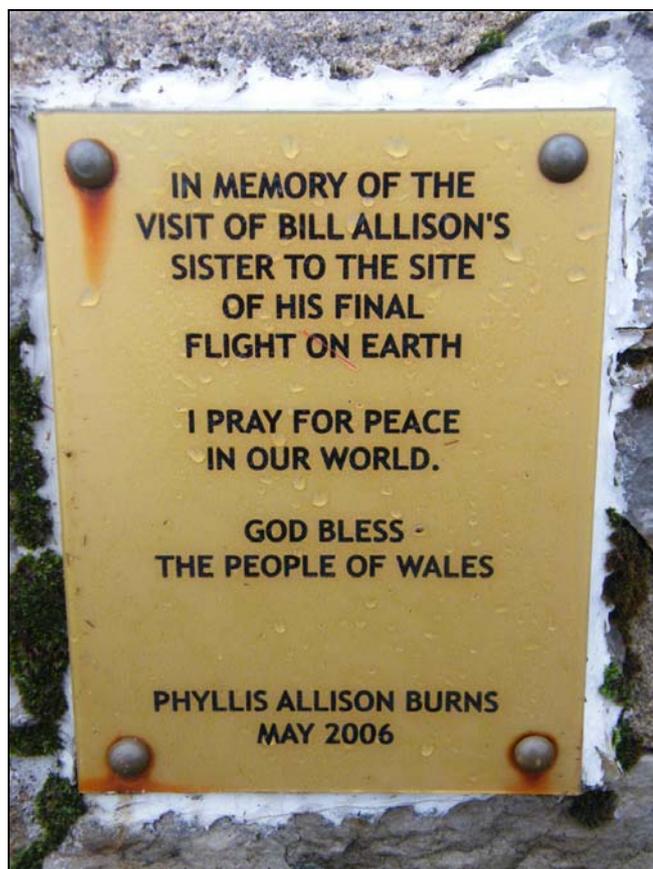
Fig. 5: The plaque added to the memorial for Wellington MF509 following the visit of one of the relatives (Photo CPAT 3732-0032)

Wreckage covers a much larger area than was apparent from the existing description. The memorial is of stone and concrete with 2 plaques, one for the crew, the other commemorating the visit in 2006 by Phyllis Burns, sister of Bill Allison, one of the crew. Several crosses and poppies had been left there, also a wreath and assorted objects. Laminated notes in a plastic folder prepared by Arwel Michael were held against the side of the memorial by a piece of steel (armour?) plate.

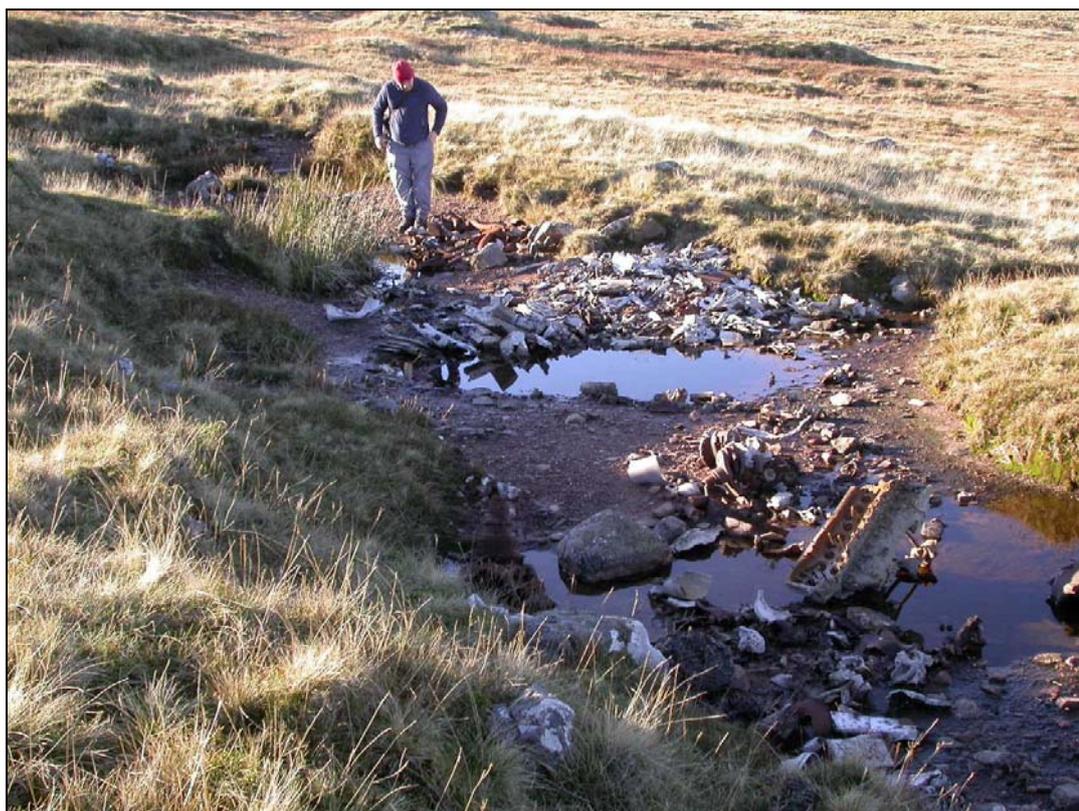
Fig. 6: Recording the high-energy crash site and debris of Avro Lancaster W4929 on the Black Mountain (Photo CPAT 3732-0026)

This Lancaster was assigned to 1661 Heavy Conversion Unit and was undertaking a night cross-country exercise from Winthorpe, Nottinghamshire, when it crashed on 5 September 1943 north of Fan Foel at around 620m. The RAF Inquiry stated that there was insufficient evidence available to establish the exact cause but that the aircraft had been underpowered when it hit the ground. Visible wreckage includes bent crankshafts, split propeller hubs and engine blocks, with much general wreckage spread over a large area. All 8 crewmen were killed. (Brecon Beacons National Park, 1995, Identification Guide Aircraft Crashes in the National Park, ID 4)
