Derwen

**SJ 0700 5070
105956**

Introduction

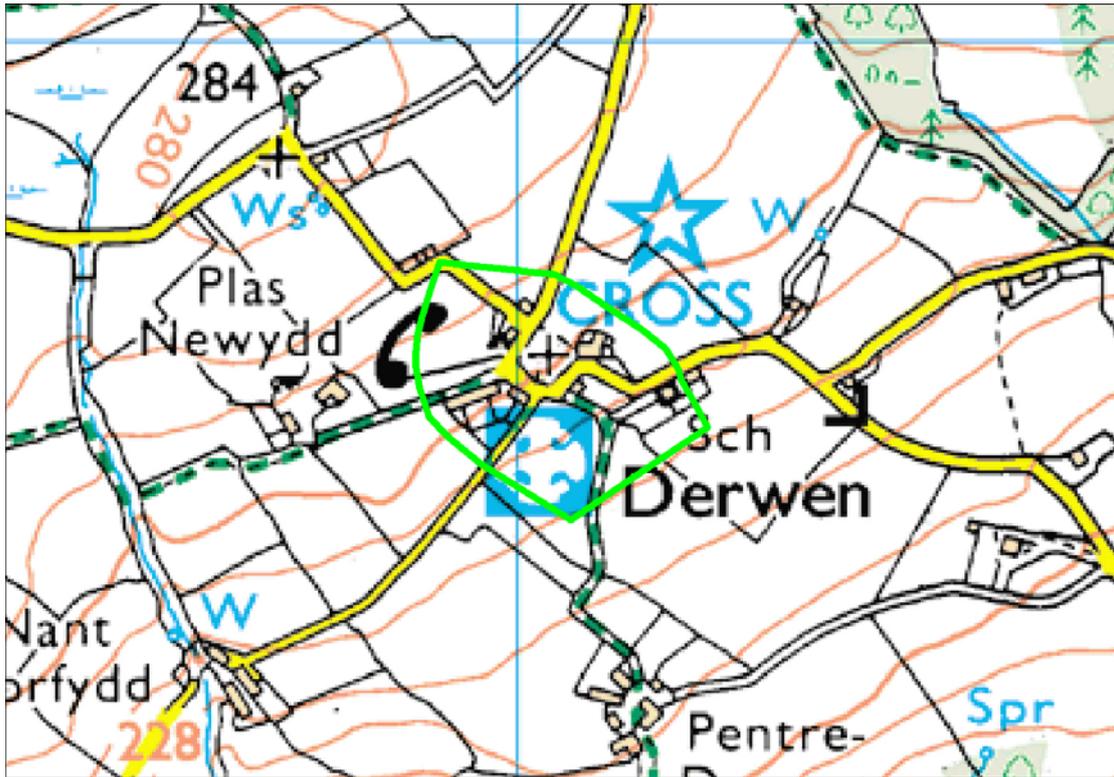
The accompanying map is offered only as an indicative guide to the historic settlement. The continuous line defining the historic core offers a visual interpretation of the area within which the settlement developed, based on our interpretation of the evidence currently to hand. It is not an immutable boundary line, and will require modification as new discoveries are made. The map does not show those areas or buildings that are statutorily designated, nor does it pick out those sites or features that are specifically mentioned in the text.
