Llanfwrog

Introduction

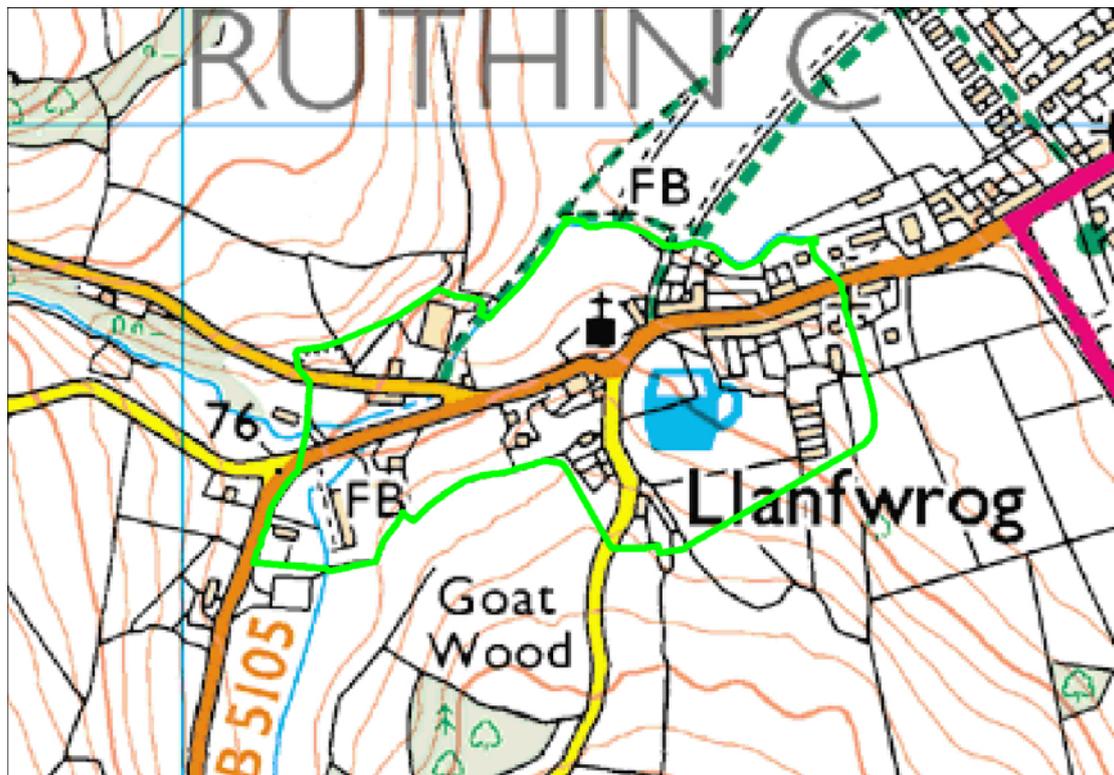
The accompanying map is offered only as an indicative guide to the historic settlement. The continuous line defining the historic core offers a visual interpretation of the area within which the settlement developed, based on our interpretation of the evidence currently to hand. It is not an immutable boundary line, and will require modification as new discoveries are made. The map does not show those areas or buildings that are statutorily designated, nor does it pick out those sites or features that are specifically mentioned in the text.
