Disserth

SO 034583
16133

Introduction

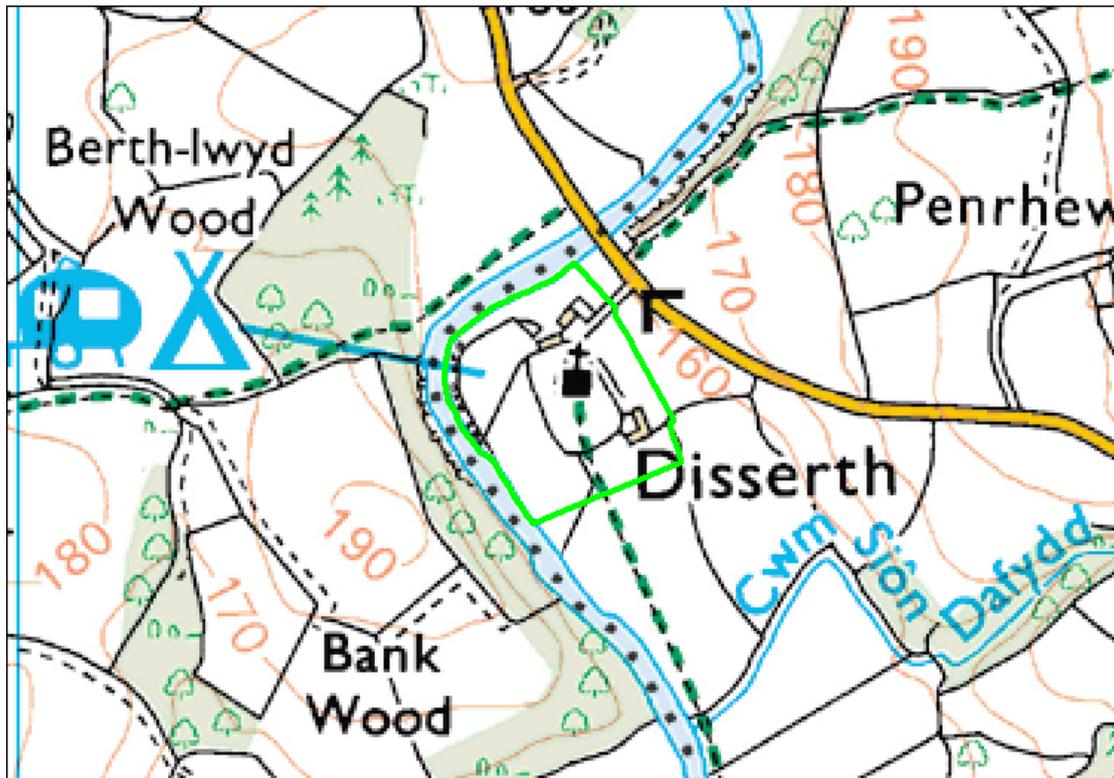
The accompanying map is offered as an indicative guide to the historic settlement. The continuous line defining the historic core offers a visual interpretation of the area within which the settlement developed, based on our interpretation of the evidence currently to hand. It is not an immutable boundary line, and may need to be modified as new discoveries are made. The map does not show those areas or buildings that are statutorily designated, nor does it pick out those sites or features that are specifically mentioned in the text.
