Llanddewi Ystradenni

Introduction

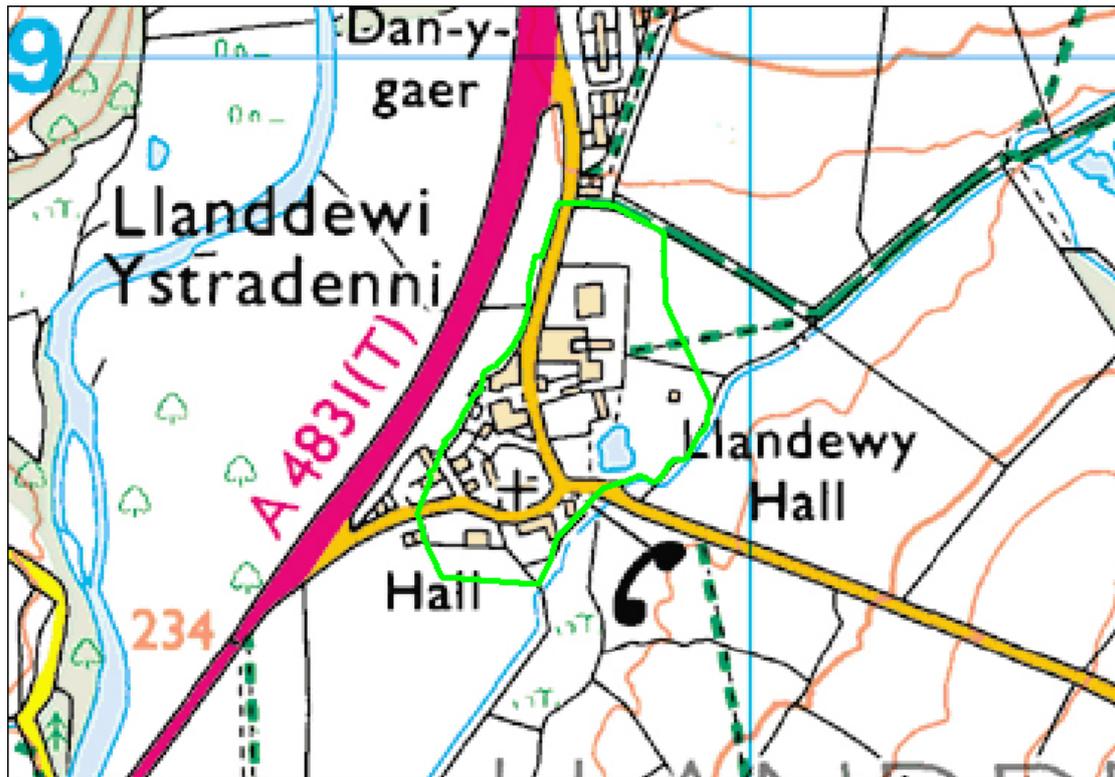
The accompanying map is offered as an indicative guide to the historic settlement. The continuous line defining the historic core offers a visual interpretation of the area within which the settlement developed, based on our interpretation of the evidence currently to hand. It is not an immutable boundary line, and may need to be modified as new discoveries are made. The map does not show those areas or buildings that are statutorily designated, nor does it pick out those sites or features that are specifically mentioned in the text.
